**12384.000**  
**Airtightness Testing Guidance**  
**and Training**  
**Guide Development**

REGARDING **Engineers and Geoscientist of British Columbia Office Building**  
**Whole-Building Airtightness Test Report**

RDH Building Science Inc. (RDH) is pleased to provide you with this report documenting the results of the whole-building airtightness testing conducted on the Engineers and Geoscientists of British Columbia office building, located at 4010 Regent St, Burnaby, BC.

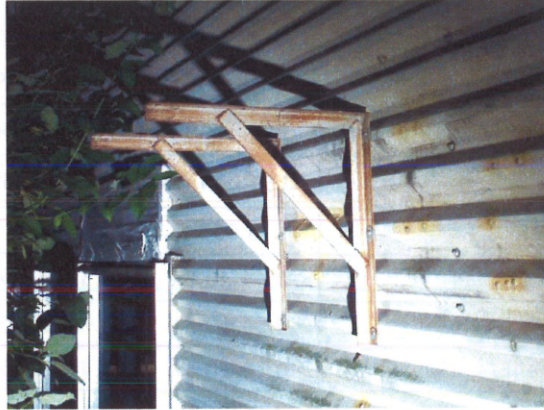
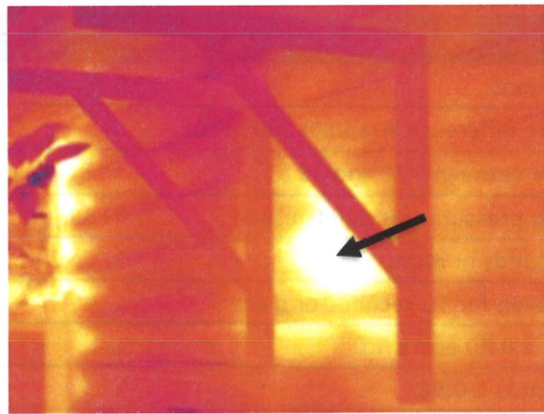
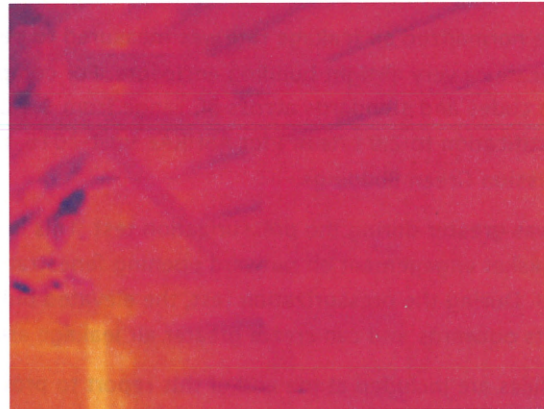
The thermographic scan identified several potential air leakage locations that may be addressed including around doors and service penetrations. An example is shown in the following series of figures:

Figure 2 L1 exterior mounting bracket located on the Southwest corner

Figure 3 Positive pressure thermal scan showing potential air leakage behind the corrugated metal cladding.

Figure 4 Negative pressure thermal scan

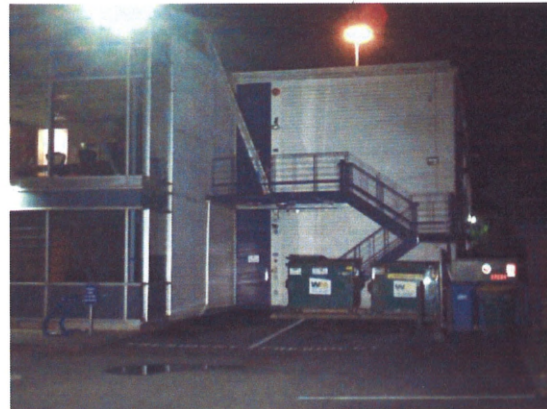
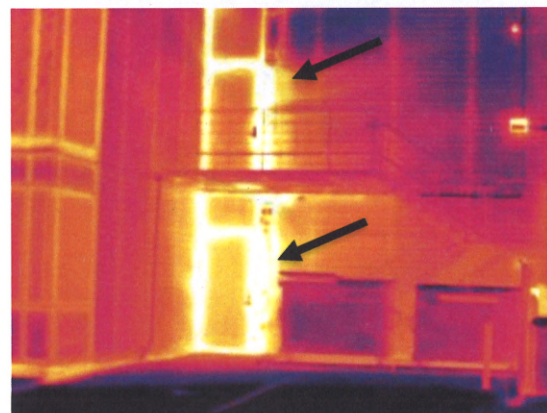
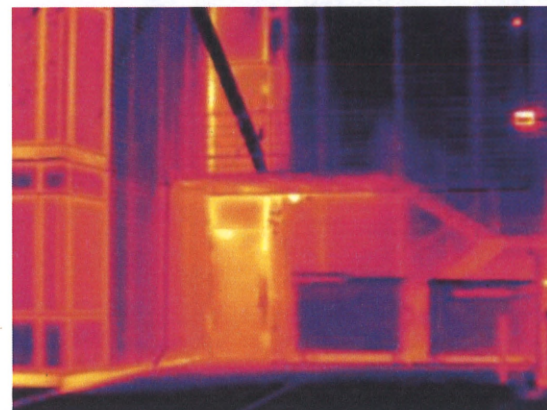
Figure 2.1 North door

Figure 2.2 Positive pressure thermal scan showing potential air leakage around the perimeter of the L1 and L2 doors

Figure 2.3 Negative pressure thermal scan

- Weather-strip all exterior doors and improve lock securement to ensure gaskets are engaged
- Seal abandoned mail slot
- At other likely locations of air leakage, smoke testing and exploratory openings could be performed to confirm air leakage paths and to facilitate design of potential repairs

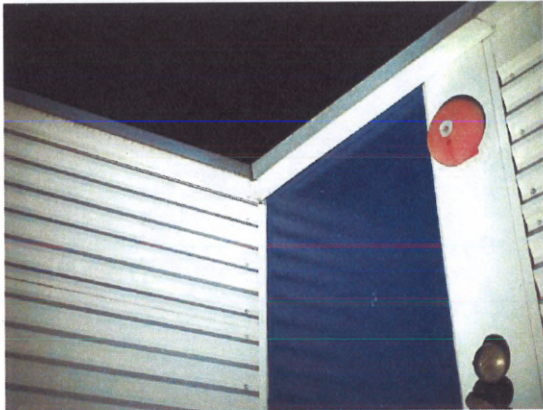
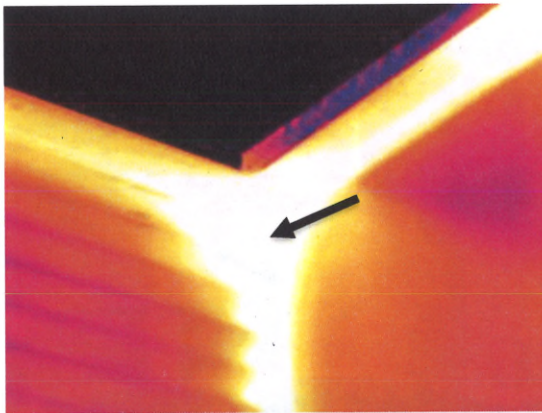
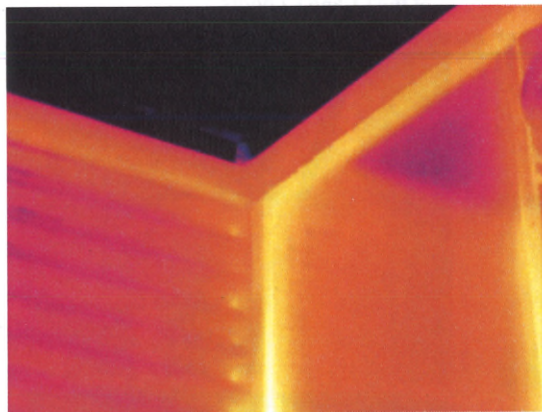
Figure 2.4 L2 northwest roof/wall corner

Figure 2.5 Positive pressure thermal scan showing potential air leakage at the corner above the L2 door

Figure 2.6 Negative pressure thermal scan

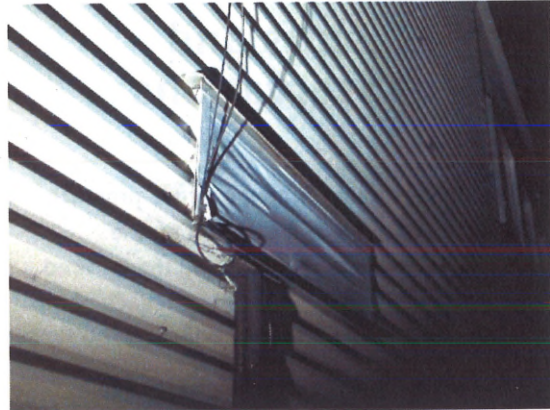
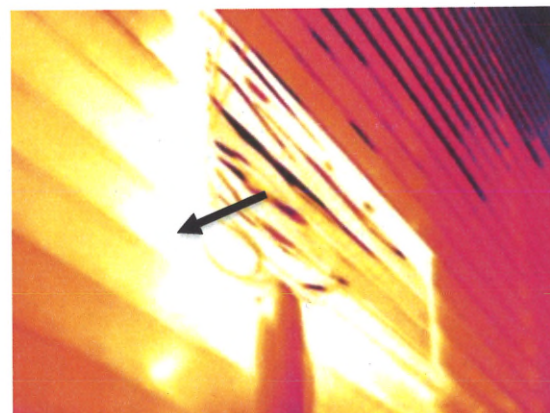
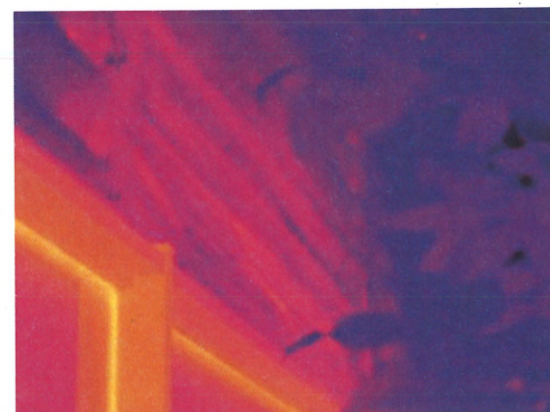
Figure 2.7 L1 louvre at the northwest corner

Figure 2.8 Positive pressure thermal scan showing potential air leakage around an exterior vent on the West elevation

Figure 2.9 Negative pressure thermal scan

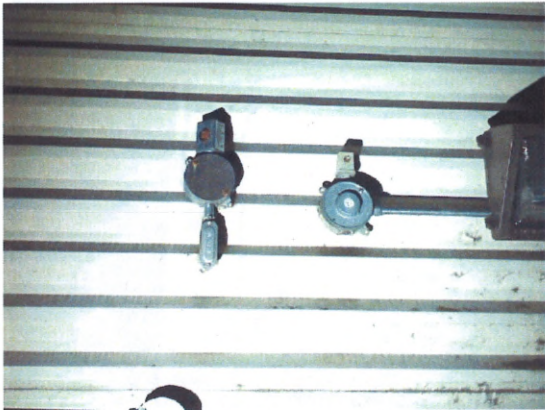
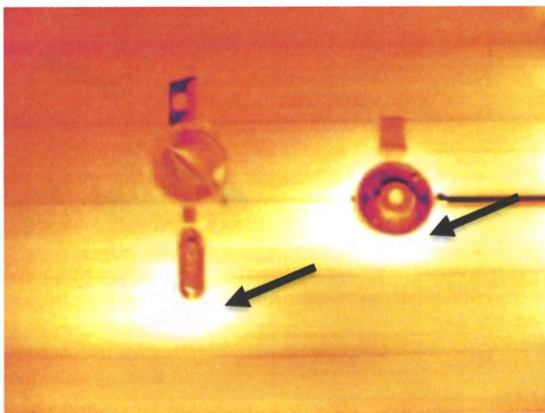
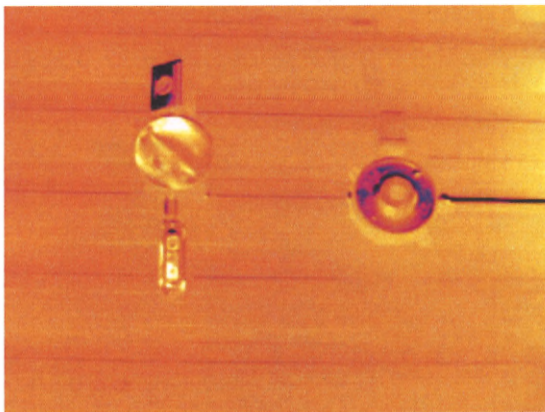
Figure 2.10 Electrical service penetrations on the west wall

Figure 2.11 Positive pressure thermal scan showing potential air leakage around the penetrations

Figure 2.12 Negative pressure thermal scan

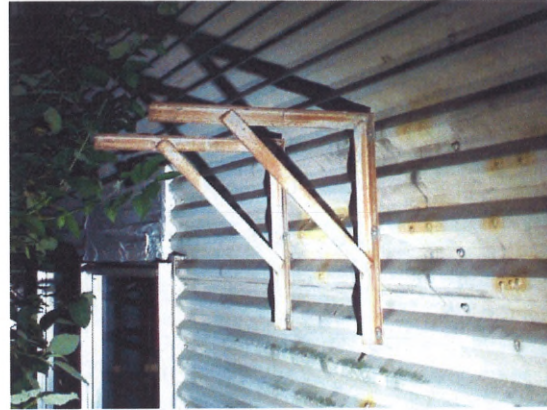
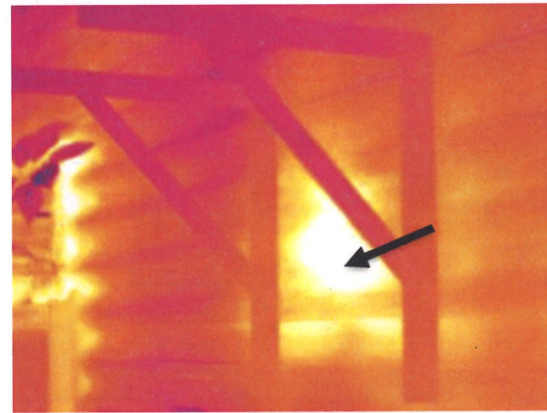
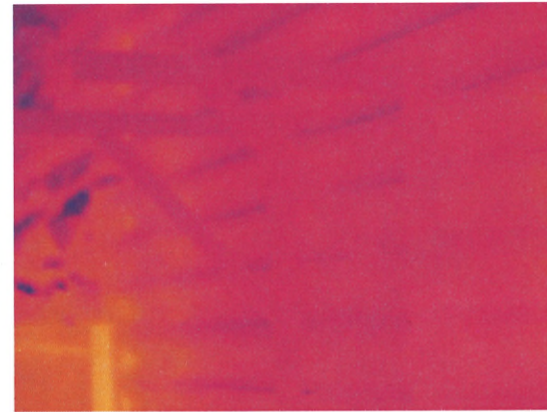
Figure 2.13 L1 exterior mounting bracket located on the Southwest corner

Figure 2.14 Positive pressure thermal scan showing potential air leakage behind the corrugated metal cladding.

Figure 2.15 Negative pressure thermal scan

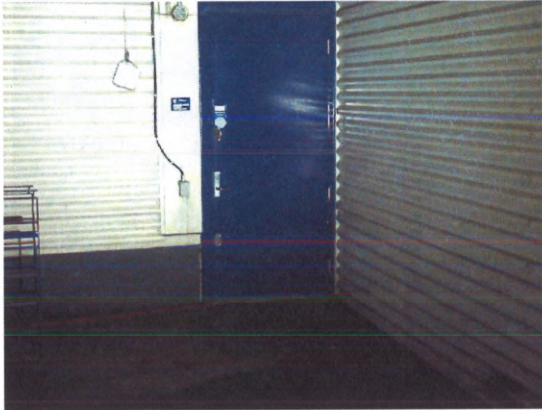
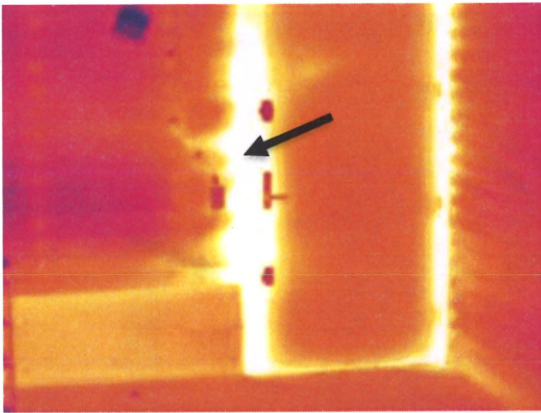
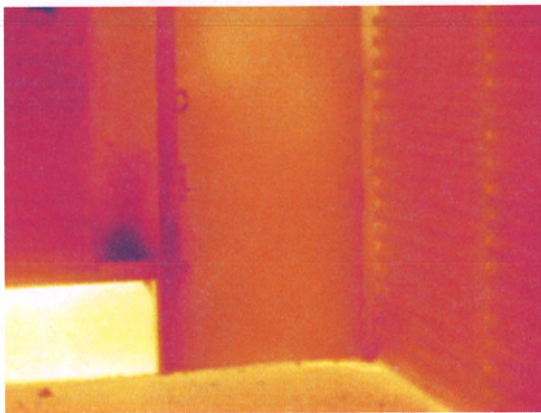
Figure 2.16 L1 southwest door

Figure 2.17 Positive pressure thermal scan showing potential air leakage around the L1 Southwest door

Figure 2.18 Negative pressure thermal scan

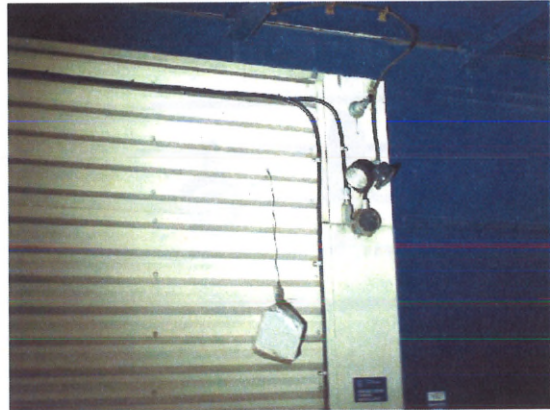
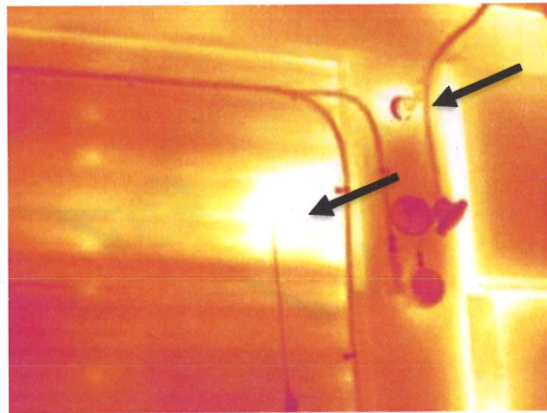
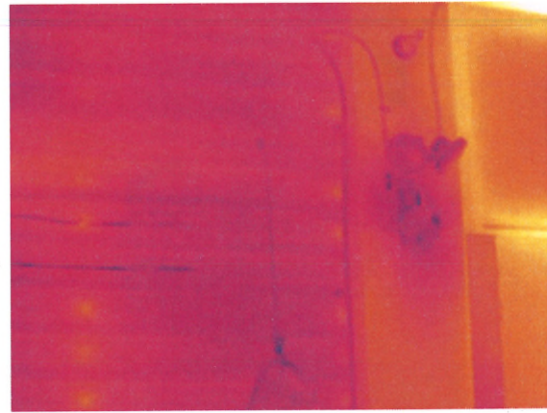
Figure 2.19 Hanging wire penetrations at the southwest corner

Figure 2.20 Positive pressure thermal scan showing potential air leakage around penetrations at the Southwest L1 door

Figure 2.21 Negative pressure thermal scan

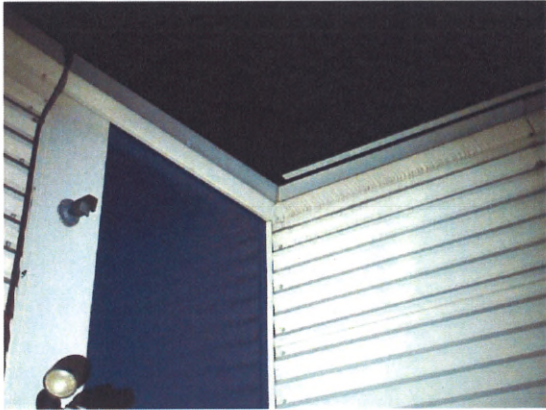
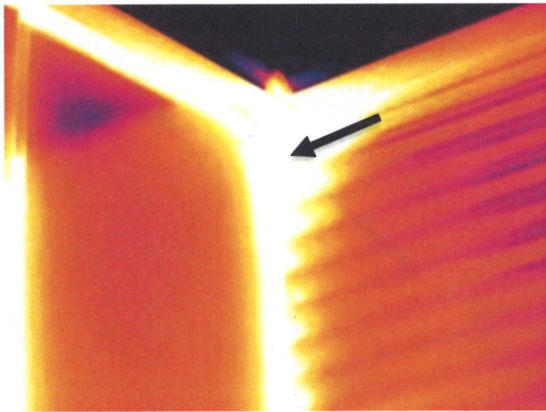
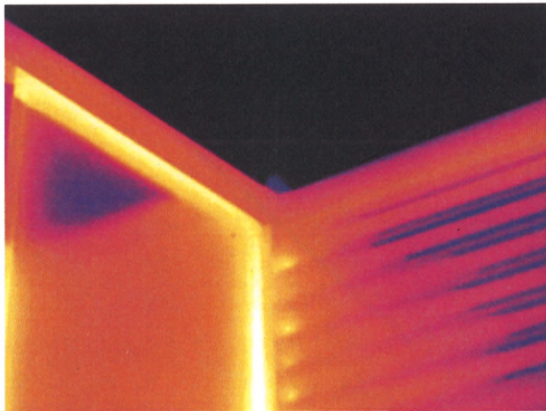
Figure 2.22 L2 southwest roof/wall corner

Figure 2.23 Positive pressure thermal scan showing potential air leakage at the top corner of the L2 Southwest door

Figure 2.24 Negative pressure thermal scan

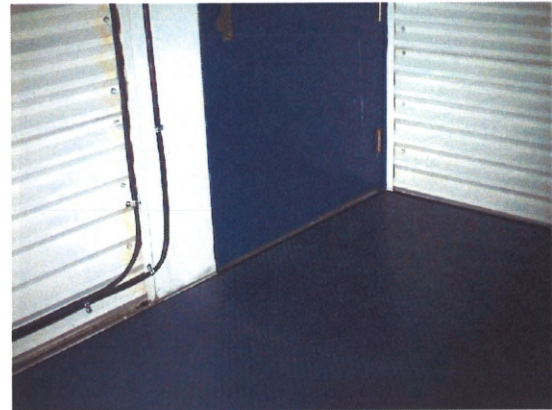
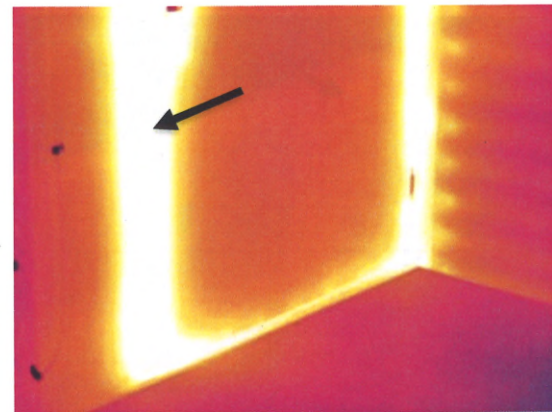
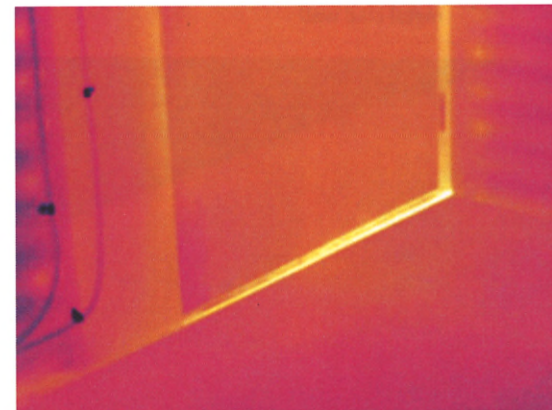
Figure 2.25 L2 southwest base of door

Figure 2.26 Positive pressure thermal scan showing potential air leakage around the L2 Southwest door

Figure 2.27 Negative pressure thermal scan

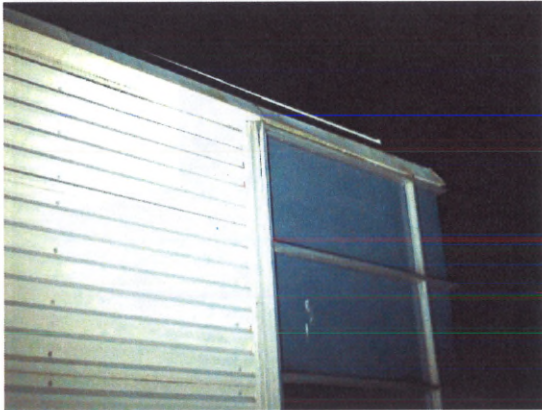
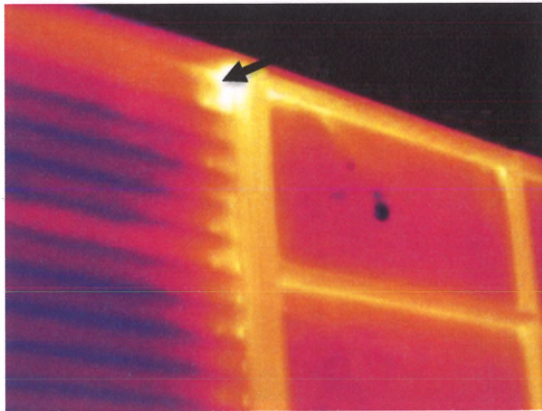
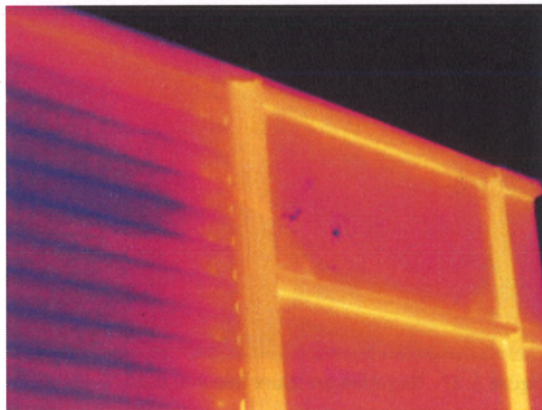
Figure 2.28 L2 southwest corner

Figure 2.29 Positive pressure thermal scan showing potential air leakage where the curtain wall turns the Southwest corner and joints the metal clad wall

Figure 2.30 Negative pressure thermal scan

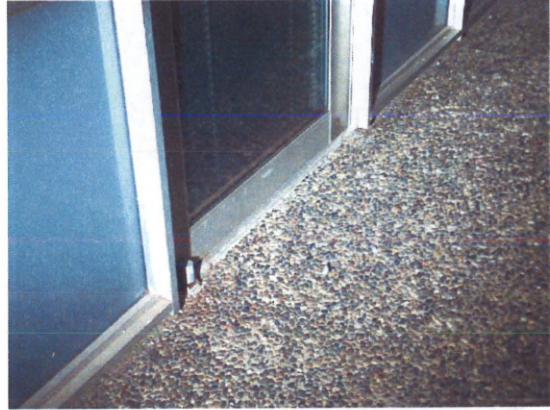
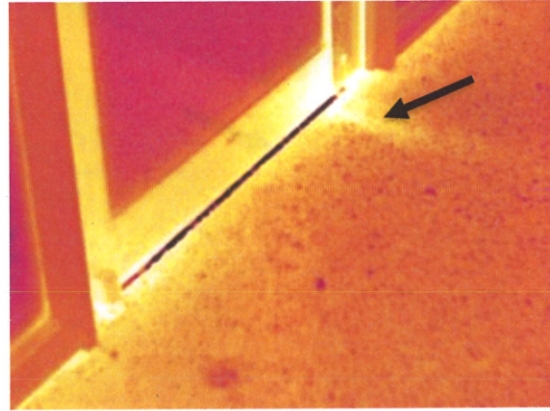
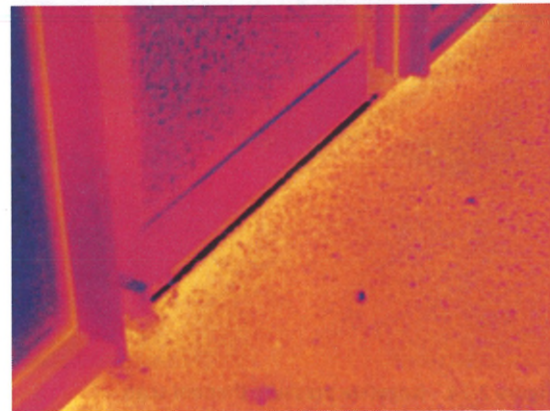
Figure 2.31 L1 southeast base of door

Figure 2.32 Positive pressure thermal scan showing potential air leakage at the base of the L1 Southeast door

Figure 2.33 Negative pressure thermal scan

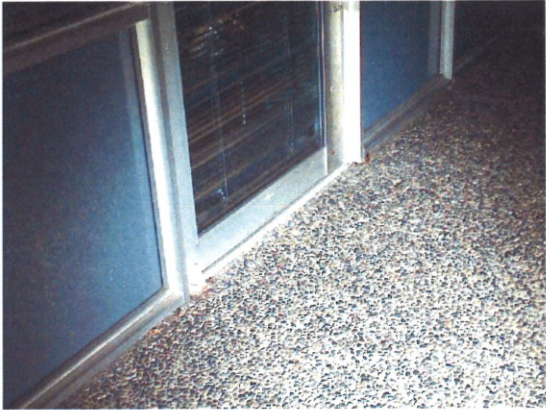
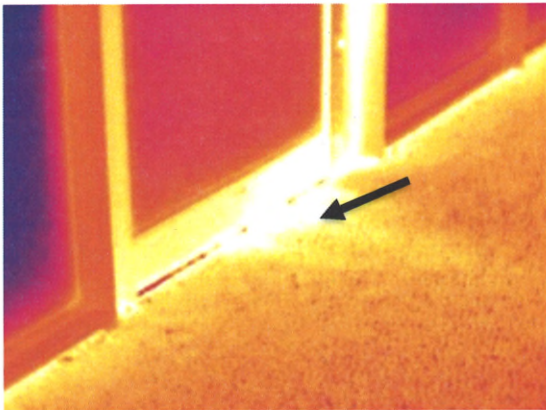
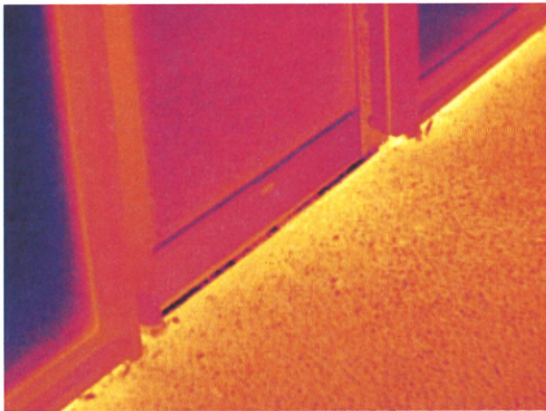
Figure 2.34 L1 base of south door

Figure 2.35 Positive pressure thermal scan showing potential air leakage at the base of the L1 South door

Figure 2.36 Negative pressure thermal scan

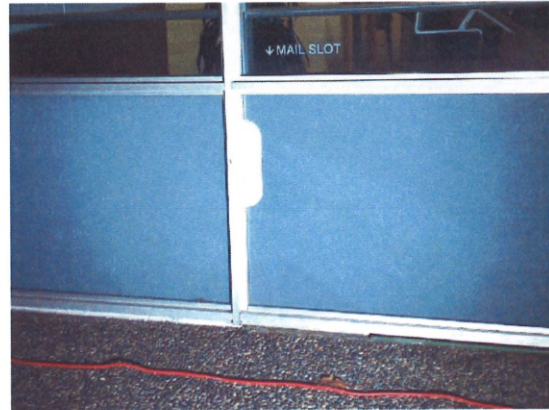
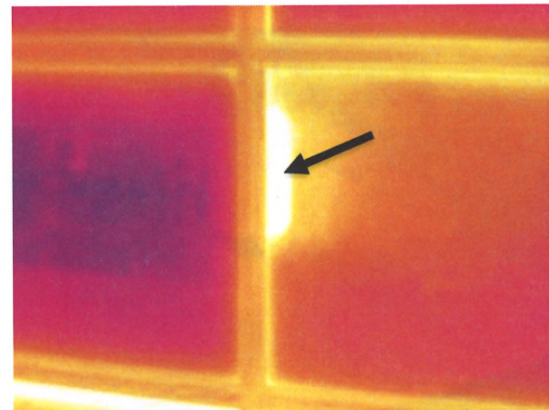
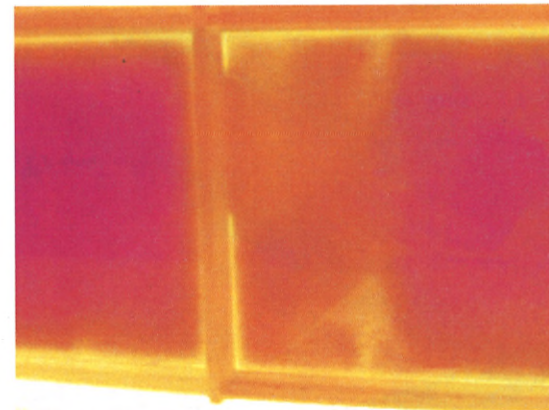
Figure 2.37 Mail slot near atrium

Figure 2.38 Positive pressure thermal scan showing potential air leakage at a mail slot on the East wall

Figure 2.39 Negative pressure thermal scan

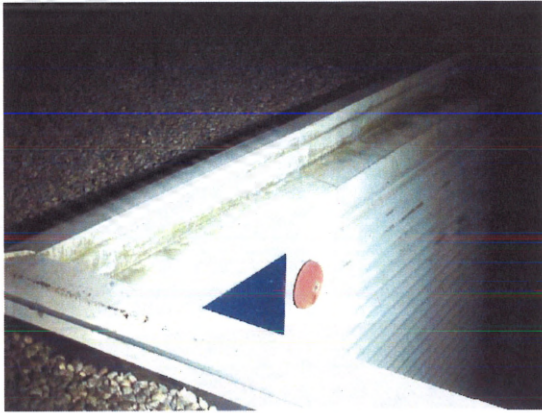
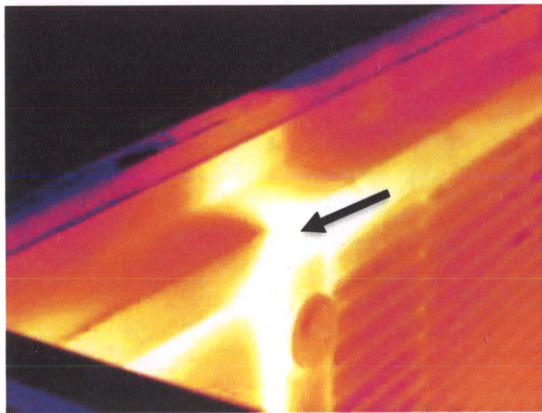
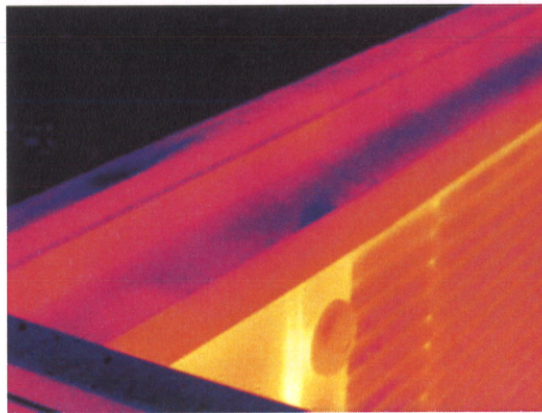
Figure 2.40 Top right corner of L2 north door

Figure 2.41 Positive pressure thermal scan showing potential air leakage around the fire alarm bell

Figure 2.42 Negative pressure thermal scan
