National Exams December 2017

07-Bld-A7, Building Envelope Design

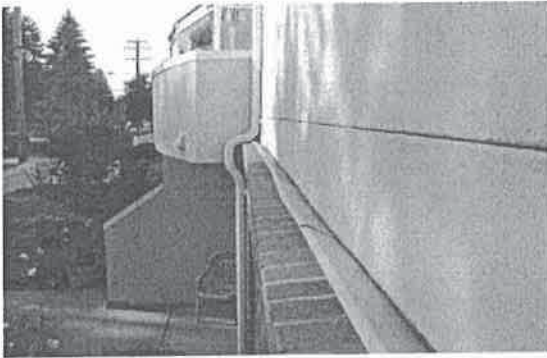
Photo 1

- 1) In a four-story wood-frame multi-unit residential building built in Vancouver, a back-sloped flashing was noticed at the second floor where the brick veneer is in transition with fiber-cement cladding, as shown in photo 1. 1) Explain what could have caused this problem. 2) What should have been done to prevent this?
- 2) Explain the failure mechanism shown in photo 2 and how to reduce the risk of such failures.
- 3) Explain the failure mechanism shown in photo 3 and how to reduce the risk of such failures.
- 4) In photo 4, note that icicles are formed at the eaves of a sloped roof. Explain what has caused it and how to avoid such a problem.

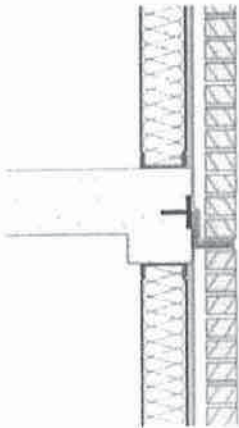
Identify thermal bridges in the cross section shown below and provide a new design to eliminate thermal bridges.

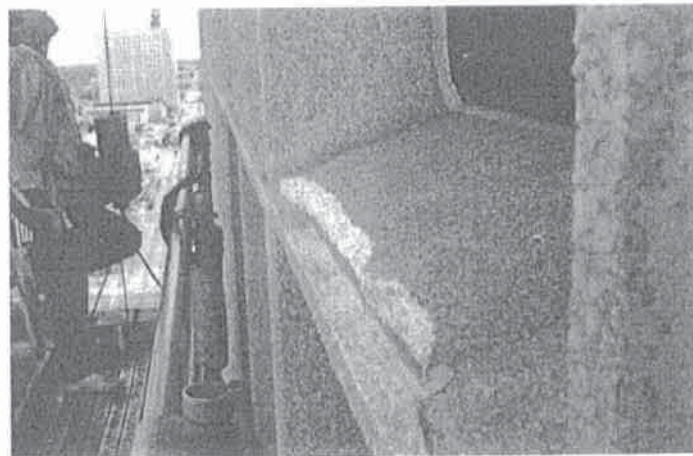
My firm recently removed large pieces of concrete from the precast concrete panels of a 20-story building (see photo). Although none fell out on their own, the pieces were loose and were removed using only plastic mallets. What is most interesting about this case is how rapidly the deterioration occurred.

During a recent follow-up, we intended to use the mallets to create a sonic response for a routine auditory survey of the concrete condition. However, we found the concrete to be so deteriorated that we were able to remove hundreds of pieces. Most of the concrete spalls were found near the edges of the panels. Some were very deep and required the removal of the entire concrete sill.

Originally, the panels were poorly fabricated with voids, honeycombing, and weak structural details at the narrow fins and embedded weep tubes. We found a plaster-type material and wood in some

The observed distress is predominantly water related. Several contributing failure mechanisms are likely:

- freeze-thaw (repeated formation of ice crystals causes microcracking)
- corrosion of embedded steel reinforcement (the corrosion product is larger than the base steel, causing internal pressure)
