National Exams May 2016

07-Bld-A7, Building Envelope Design

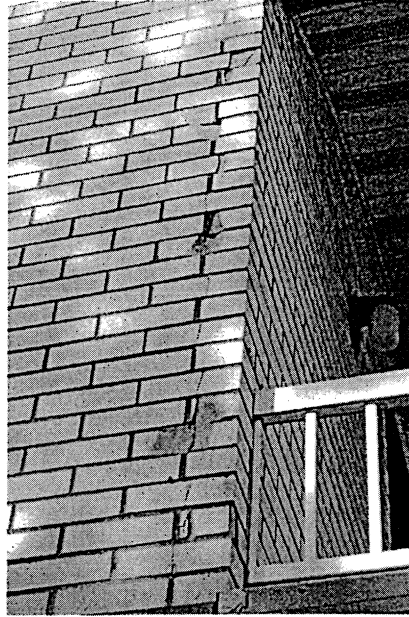
Photo 3

3. (5 marks). As shown in the photo below, cracks and spalling of bricks are noted at the corner of this brick veneer wall. Explain what has potentially contributed to this failure and what should have been done to avoid such a failure.
