National Exams May 2019

07-Bld-A7, Building Envelope Design

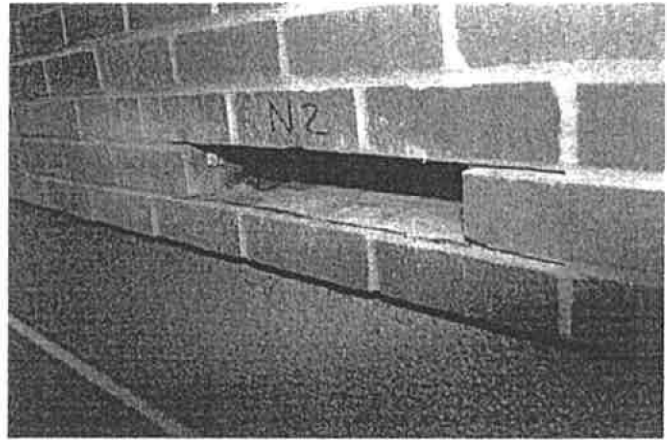
At first glance, this photo of a brick masonry wall excavation might appear to reveal satisfactory construction details. So why does this building leak like a sieve?

Water can run under
flashing that does not
extend past the wall.

The Brick Institute of America (BIA) recommends a minimum 50 mm (2 in.) wide cavity to prevent mortar droppings from clogging the cavity, creating mortar bridges between the veneer and back-up wall and blocking the weep holes. Although the cavity in the photo is narrower

and substantial mortar droppings were found, the droppings cannot be the cause of the pervasive leaking observed.

In the photo, the joints are reasonably well filled. They are also tooled concave, which is the best mortar joint profile for shedding water off the face of the wall, and there is not an excessive amount (i.e., more than 15 percent) of joint separations (shrinkage cracks).

Weep holes are on 610 mm (24 in.) centers, as BIA recommends. They are fully open head joints, which drain better than weep tubes, and are baffled to prevent insects from nesting inside them.

still elastic. Unreinforced PVC flashings are notorious for developing holes, embrittling, and shrinking.¹ The flashing in the photo is in good condition because of the product type, and the seams are well lapped.

On this building, we performed systematic water testing and demonstrated conclusively that the source of the leakage is simply because the flashing does not extend past the face of the wall.

Another unusual detail is the use of a grout dam: the flashing is raised one course and rests on the mortar-filled collar joint. Use of the grout dam leaves one course of masonry around each entire floor with no cavity, flashing, or weep holes. No doubt this detail exacerbates the leakage. ♦
